Chronic Venous Ulcer

Type of Wound Chronic venous ulcer*
Etiology Venous insufficiency with 5-year open wound on the medial and lateral side of the lower left leg
Patient 51-year-old male

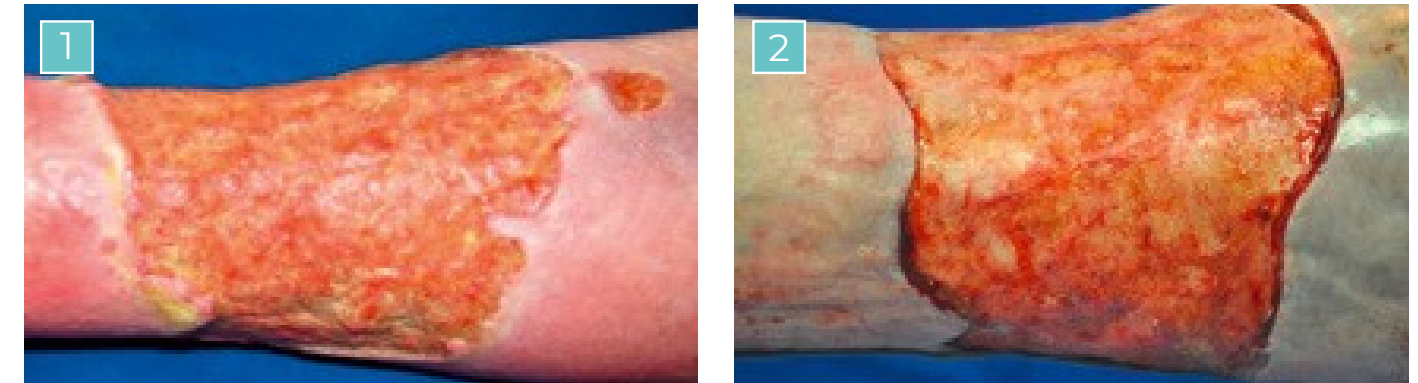
On first examination the wound bed appeared fibrinous and was covered with a yellowish layer, but there were no signs of necrotic tissue (Fig. 1). The wound bed was treated with non-adherent gauze for 6 months prior to surgery. Antibiotics were administered and the wound was cleansed once with chlorhexidine.

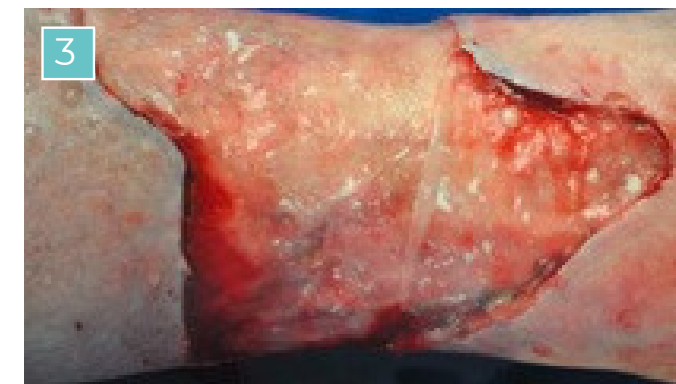
During the surgery the wound bed was properly debrided (Fig. 2) prior to dry application of 1 mm MatriDerm®. The matrix was rehydrated inside the wound bed (Fig. 3). MatriDerm® was covered with a 0.010 inch, unmeshed, fenestrated split-thickness skin graft (STSG) (Fig. 4). MatriDerm® and the STSG were fixated with 6 layers of fatty gauze and V.A.C. therapy with the GranuFoam dressing was applied for 5 days (100 mmHg, continuous negative pressure) (Fig. 5). At 14 days p.o. the take rate of the STSG was 95% and at 1 month the skin graft was completely integrated with full and stable wound closure, and the patient was able to wear compression socks for his venous insufficiency.

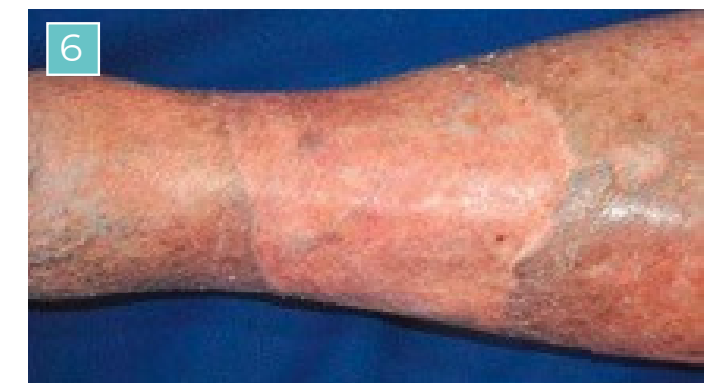
3.5 years follow-up showed very stable wound closure with good aesthetic outcome. The wound edges are leveled with the surrounding healthy tissue (Fig. 6) and the patient has full functional results with extension and flexion of his leg (Fig. 7). Excellent wound elasticity and pliability was achieved (Fig. 8).
